ECG Contest

Response to ECG, December 2016

Jaume Francisco-Pascual*

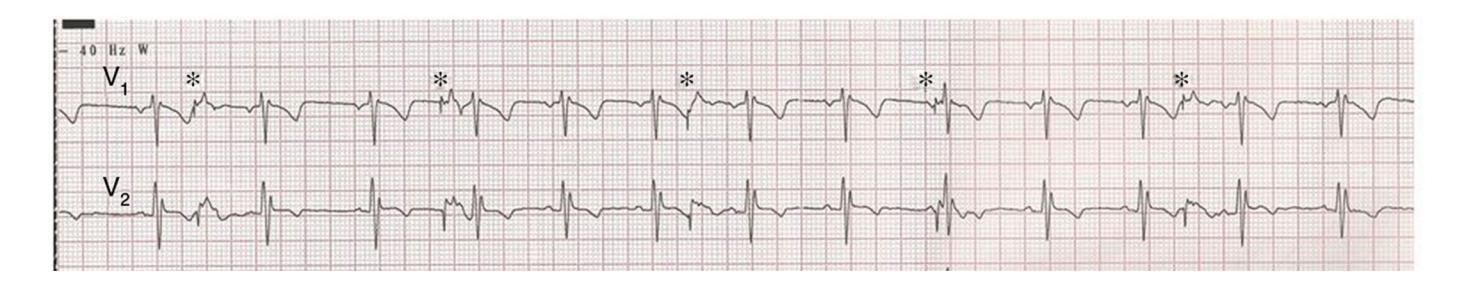
Figure 1.

The electrocardiogram showed sinus P waves at a heart rate of about 75 bpm, with a normal PR interval, 1:1 conduction, and QRS morphology indicative of incomplete right bundle branch block. In addition, pacing spikes of the implantable cardioverter defibrillator (ICD) (Figure 1, asterisks) were seen at a heart rate of about 30 bpm (normally the back-up pacing heart rate used in ICD programming for patients not requiring cardiac pacing), compatible with a ventricular sensing failure. These spikes provoked a heterogeneous action potential morphology that had no effect on the atrial and ventricular cycles, indicating capture of an extracardiac structure. Chest radiography (Figure 2) showed dislodgement of the lead toward the pectoral region due to apparent rotation of the device on its sagittal axis, which would produce capture of the chest muscles (correct answer, no. 1).
