Image in cardiology

A Serious Complication in a Patient With a Ventricular Assist Device

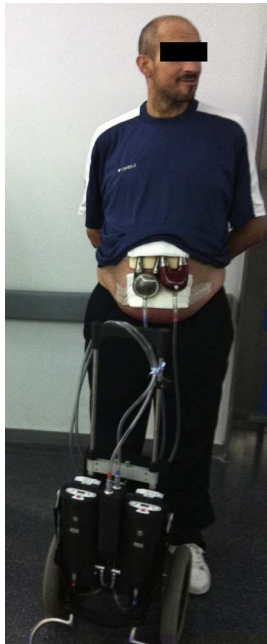
Figure 1.

We report the case of a 47-year-old man with end-stage ischemic heart disease who underwent implantation of a Berlin Heart EXCOR[®] biventricular assist device (VAD) as a bridge to transplantation (Figure 1). He received oral anticoagulation and dual antiplatelet therapy with acetylsalicylic acid and clopidogrel, according to the standard protocol until, 1 month later, he had a hemorrhagic stroke that left no sequelae. Therefore, the decision was made to discontinue the antiplatelet therapy and to treat the patient with acenocoumarol alone.

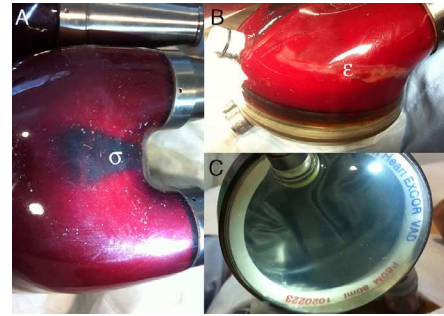
Figure 2.

Three months later, he came to the emergency service because of a warning from the VAD that indicated low flow in the system. He had an international normalized ratio (INR) of 2.6. Inspection of the left VAD (Figures 2A and 2B and video clip [supplementary material]) revealed a moving shadow (σ) associated with a thrombus that grew rapidly (ϵ) within the blood chamber, in addition to an abnormal expansion of the outer membrane during systole (Figure 2C). As we suspected rupture of 1 of the membranes that separate the 2 chambers (blood and air) and because of the risk of systemic embolization of the thrombus, the left VAD cannulas were rapidly clamped and the flow in the right VAD was reduced to prevent acute pulmonary edema. The malfunctioning VAD was replaced, (Figure 3) and rupture of the inner membrane (*) of the explanted device and the presence of a large associated thrombus (δ) were confirmed. The outcome of this replacement was favorable and the patient received a transplant several weeks later.
