Image in cardiology

Percutaneous Repair of a Complex Periprosthetic Aortic Leak

Leire Unzué,^{a,*} Eulogio García,^a and Belén Díaz-Antón^b^a Unidad de Hemodinámica y Cardiología Intervencionista, Hospital Universitario Madrid Montepríncipe, Boadilla del Monte, Madrid, Spain^b Unidad de Imagen Cardíaca, Hospital Universitario Madrid Montepríncipe, Boadilla del Monte, Madrid, Spain

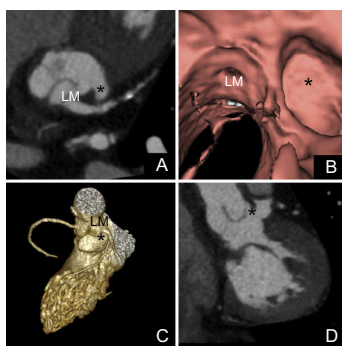
Figure 1.

A 59-year old man with a supracoronary graft developed aortic endocarditis, requiring urgent valve replacement through implantation of a biological stentless Sorin aortic valve. Three months after the intervention, he experienced minimal effort angina. A transesophageal echocardiogram showed a periprosthetic leak, causing severe aortic regurgitation. The patient was rejected for a new surgical intervention, and percutaneous closure of the leak was planned. A computed tomography (CT) scan showed a wide perivalvular leak (Figure 1A, Figure 1B, Figure 1C, Figure 1D, asterisk), connected to a periannular cavity situated between the superior left ventricle outflow tract and the aortic wall, close to the left main coronary artery ostium. Ventricular angiography and aortography demonstrated the presence of a pseudoaneurysm formed by dehiscence of the suture line of the prosthetic ring, thus closely related to the leak (Figure 2A, Video 1 of the supplementary material). A wire was advanced to protect the LM, and a 5 × 10 mm vascular plug 2 was placed into the leak (Figure 2A, Figure 2B, Figure 2C, Video 2 of the supplementary material), with protrusion of the proximal disc into the LM (Video 3 of the supplementary material). A 5 × 15-mm drug-eluting stent was then implanted at the coronary ostium (Figure 2D, Figure 2E, Figure 2F, Video 4, Video 5 of the supplementary material), achieving complete apposition of the plug at the leak entrance, with mild residual aortic regurgitation (Video 6 of the supplementary material). The patient was discharged 2 days after the procedure and remains asymptomatic 6 months later. The follow-up CT scan showed good position of the device (Figure 3, arrow) and the LM stent (asterisk). In complex paravalvular leaks, an exhaustive study of the anatomy is essential to design a tailored strategy for the procedure.
